California Tree and Landscape Consulting, Inc.

Arborist Report

**Green Valley Road Benefits
El Dorado County, CA 95682**

**Arborist Report for Oak Woodland Resources
For Project Development**

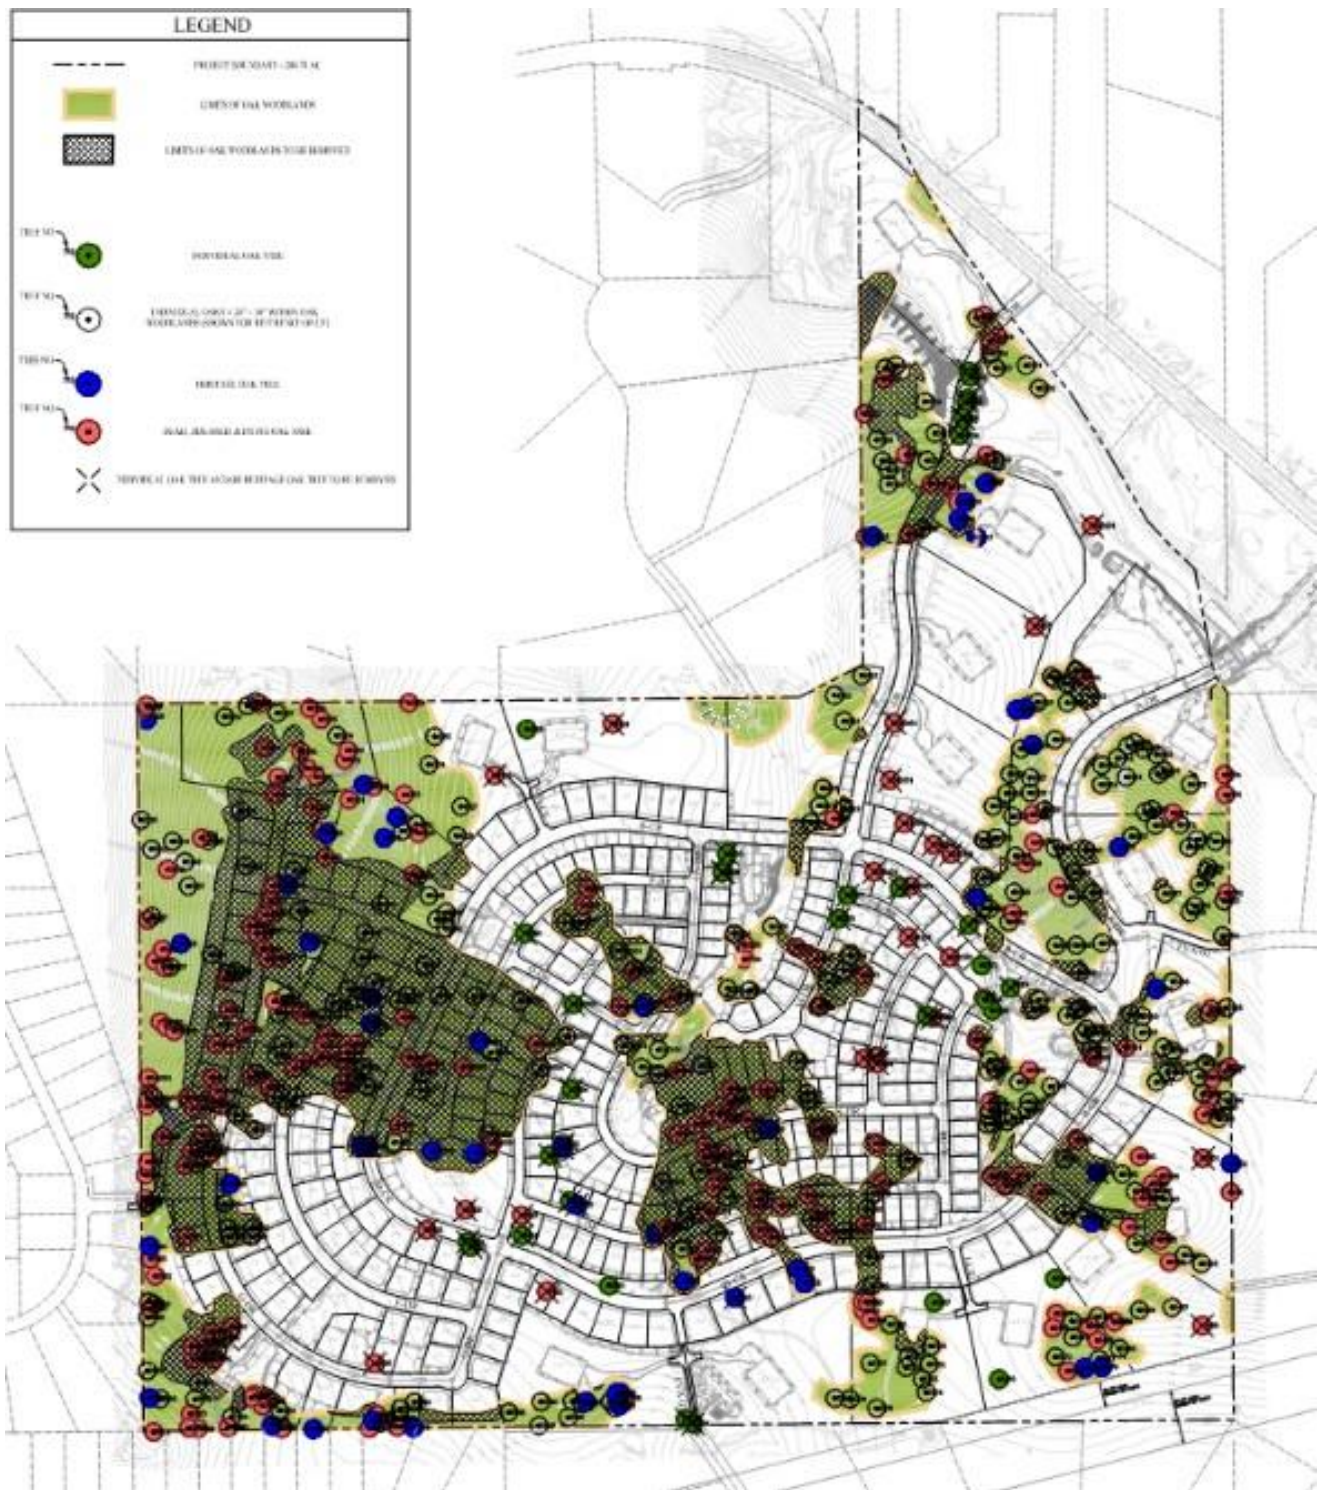
Madrone's Oak Woodland and Individual Oak Tree Survey

Site plan image with trees inspected for the project
Oak woodland light green,
proposed removals within oak woodland hashed/dark green,
Individual Oaks to be removed x's
