HELIX Environmental Planning, Inc.
1677 Eureka Road, Suite 100
Roseville, CA 95661
916.435.1202 tel
619.462.0552 fax
www.helixepi.com

November 10, 2020

Subject: El Dorado Hills 52 Oak Resources Technical Report

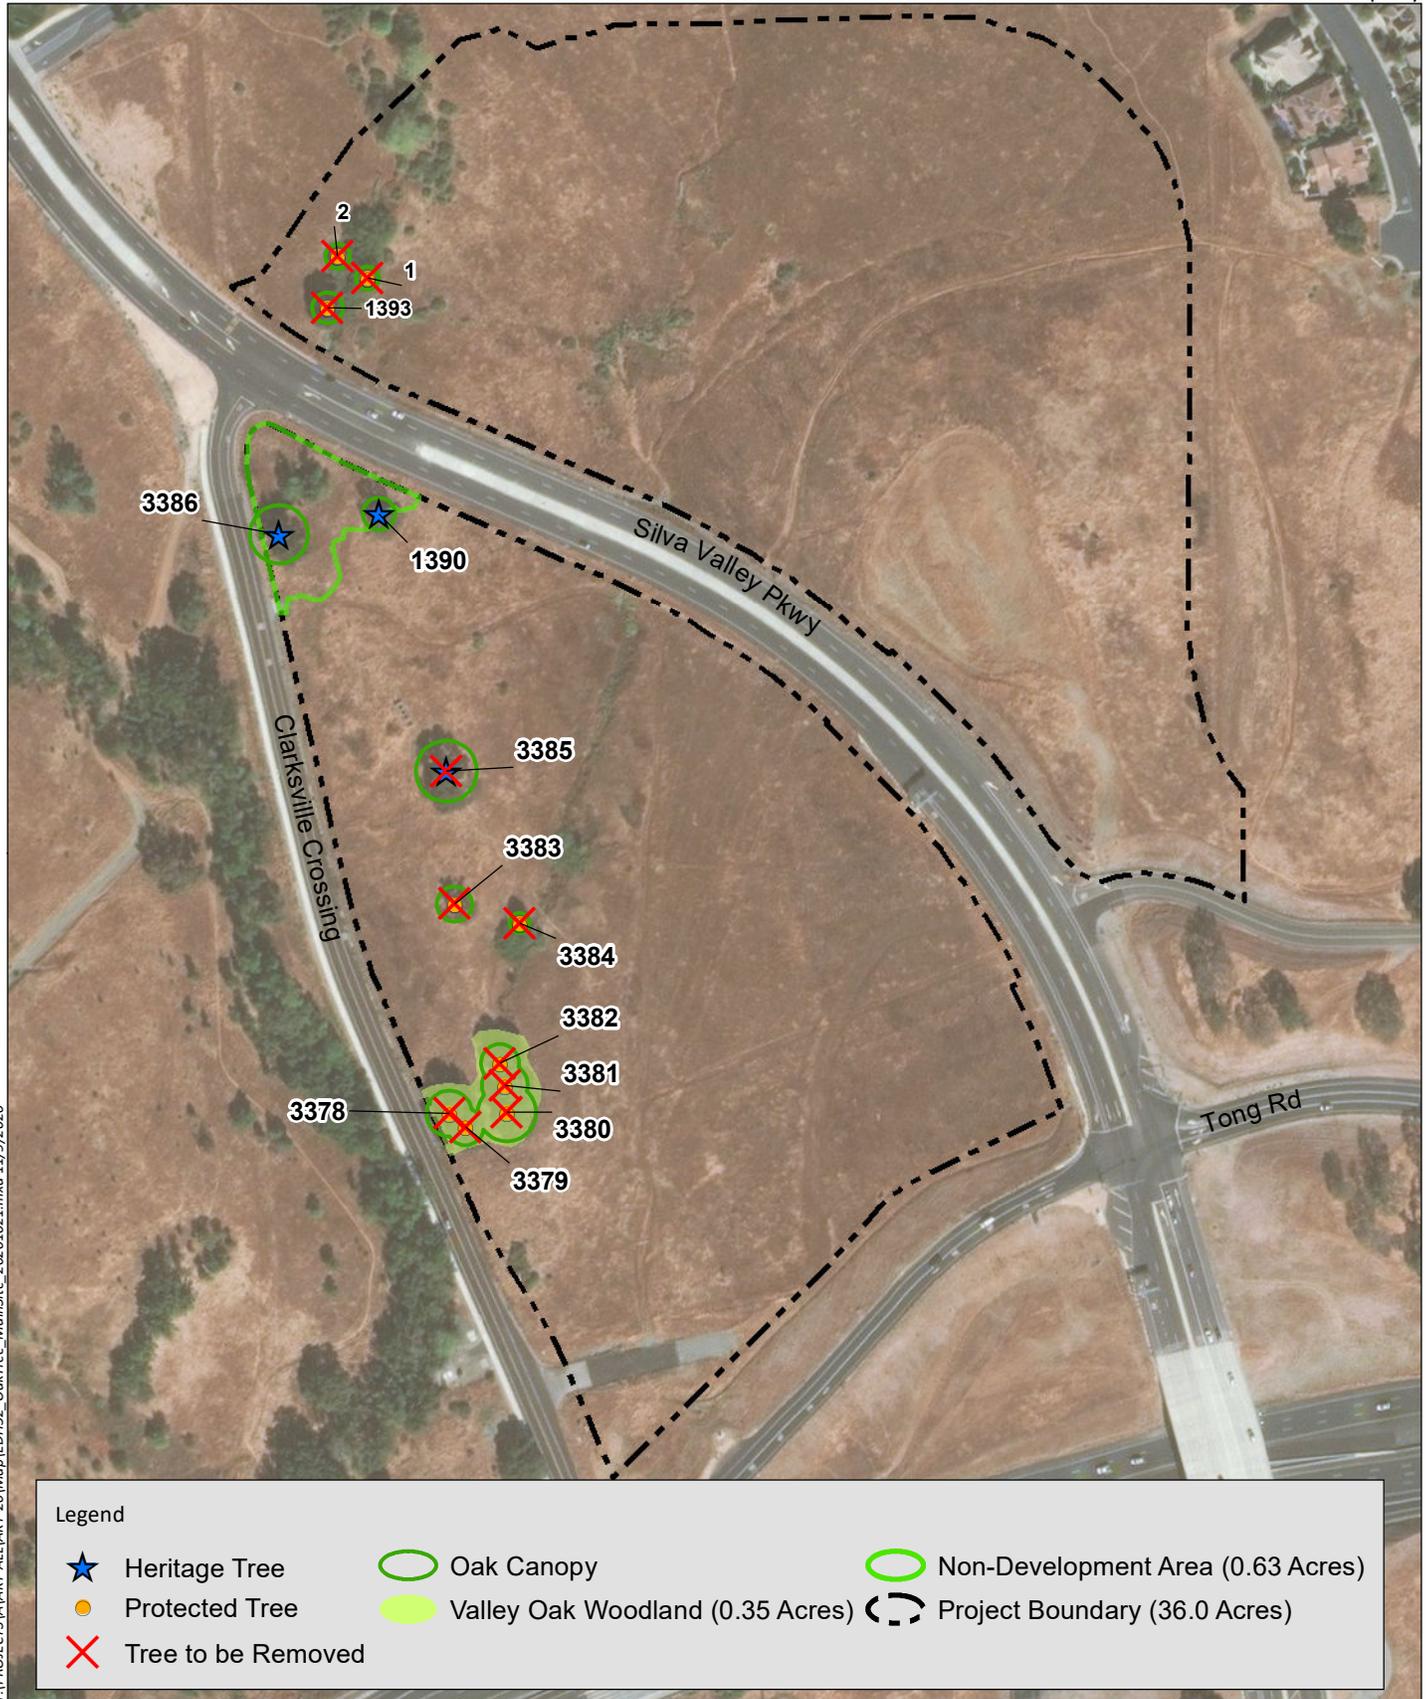
Figure 1: Existing Oak Resources and Project Impacts

In total, there is 0.35 acre of valley oak woodland located on the South Site (Figure 1). The valley oak woodland is located along the southwest boundary of the South Site along a small perennial drainage. The understory is composed primarily of annual grasses and forbs such as soft chess (*Bromus hordeaceus*), wild oat (*Avena fatua*), milkweed (*Asclepius fascicularis*), and pennyroyal (*Mentha pulegium*).

A total of 13 protected oak trees consisting of 11 valley oaks (*Quercus lobata*), one interior live oak (*Quercus wislizeni*), and 1 blue oak (*Quercus douglasii*) are present on the Project Site. Two small oaks along the central marsh are too small to be protected under the ORMP. Three trees (#1390, 3385, and 3386) are Heritage Trees. Eight trees are individual trees located outside of oak woodlands. Tree data are shown in Table 2 and tree locations are shown on Figure 1.
