# **Biological Resources Assessment**

## Town & Country Village El Dorado

El Dorado County, California  
July 2024

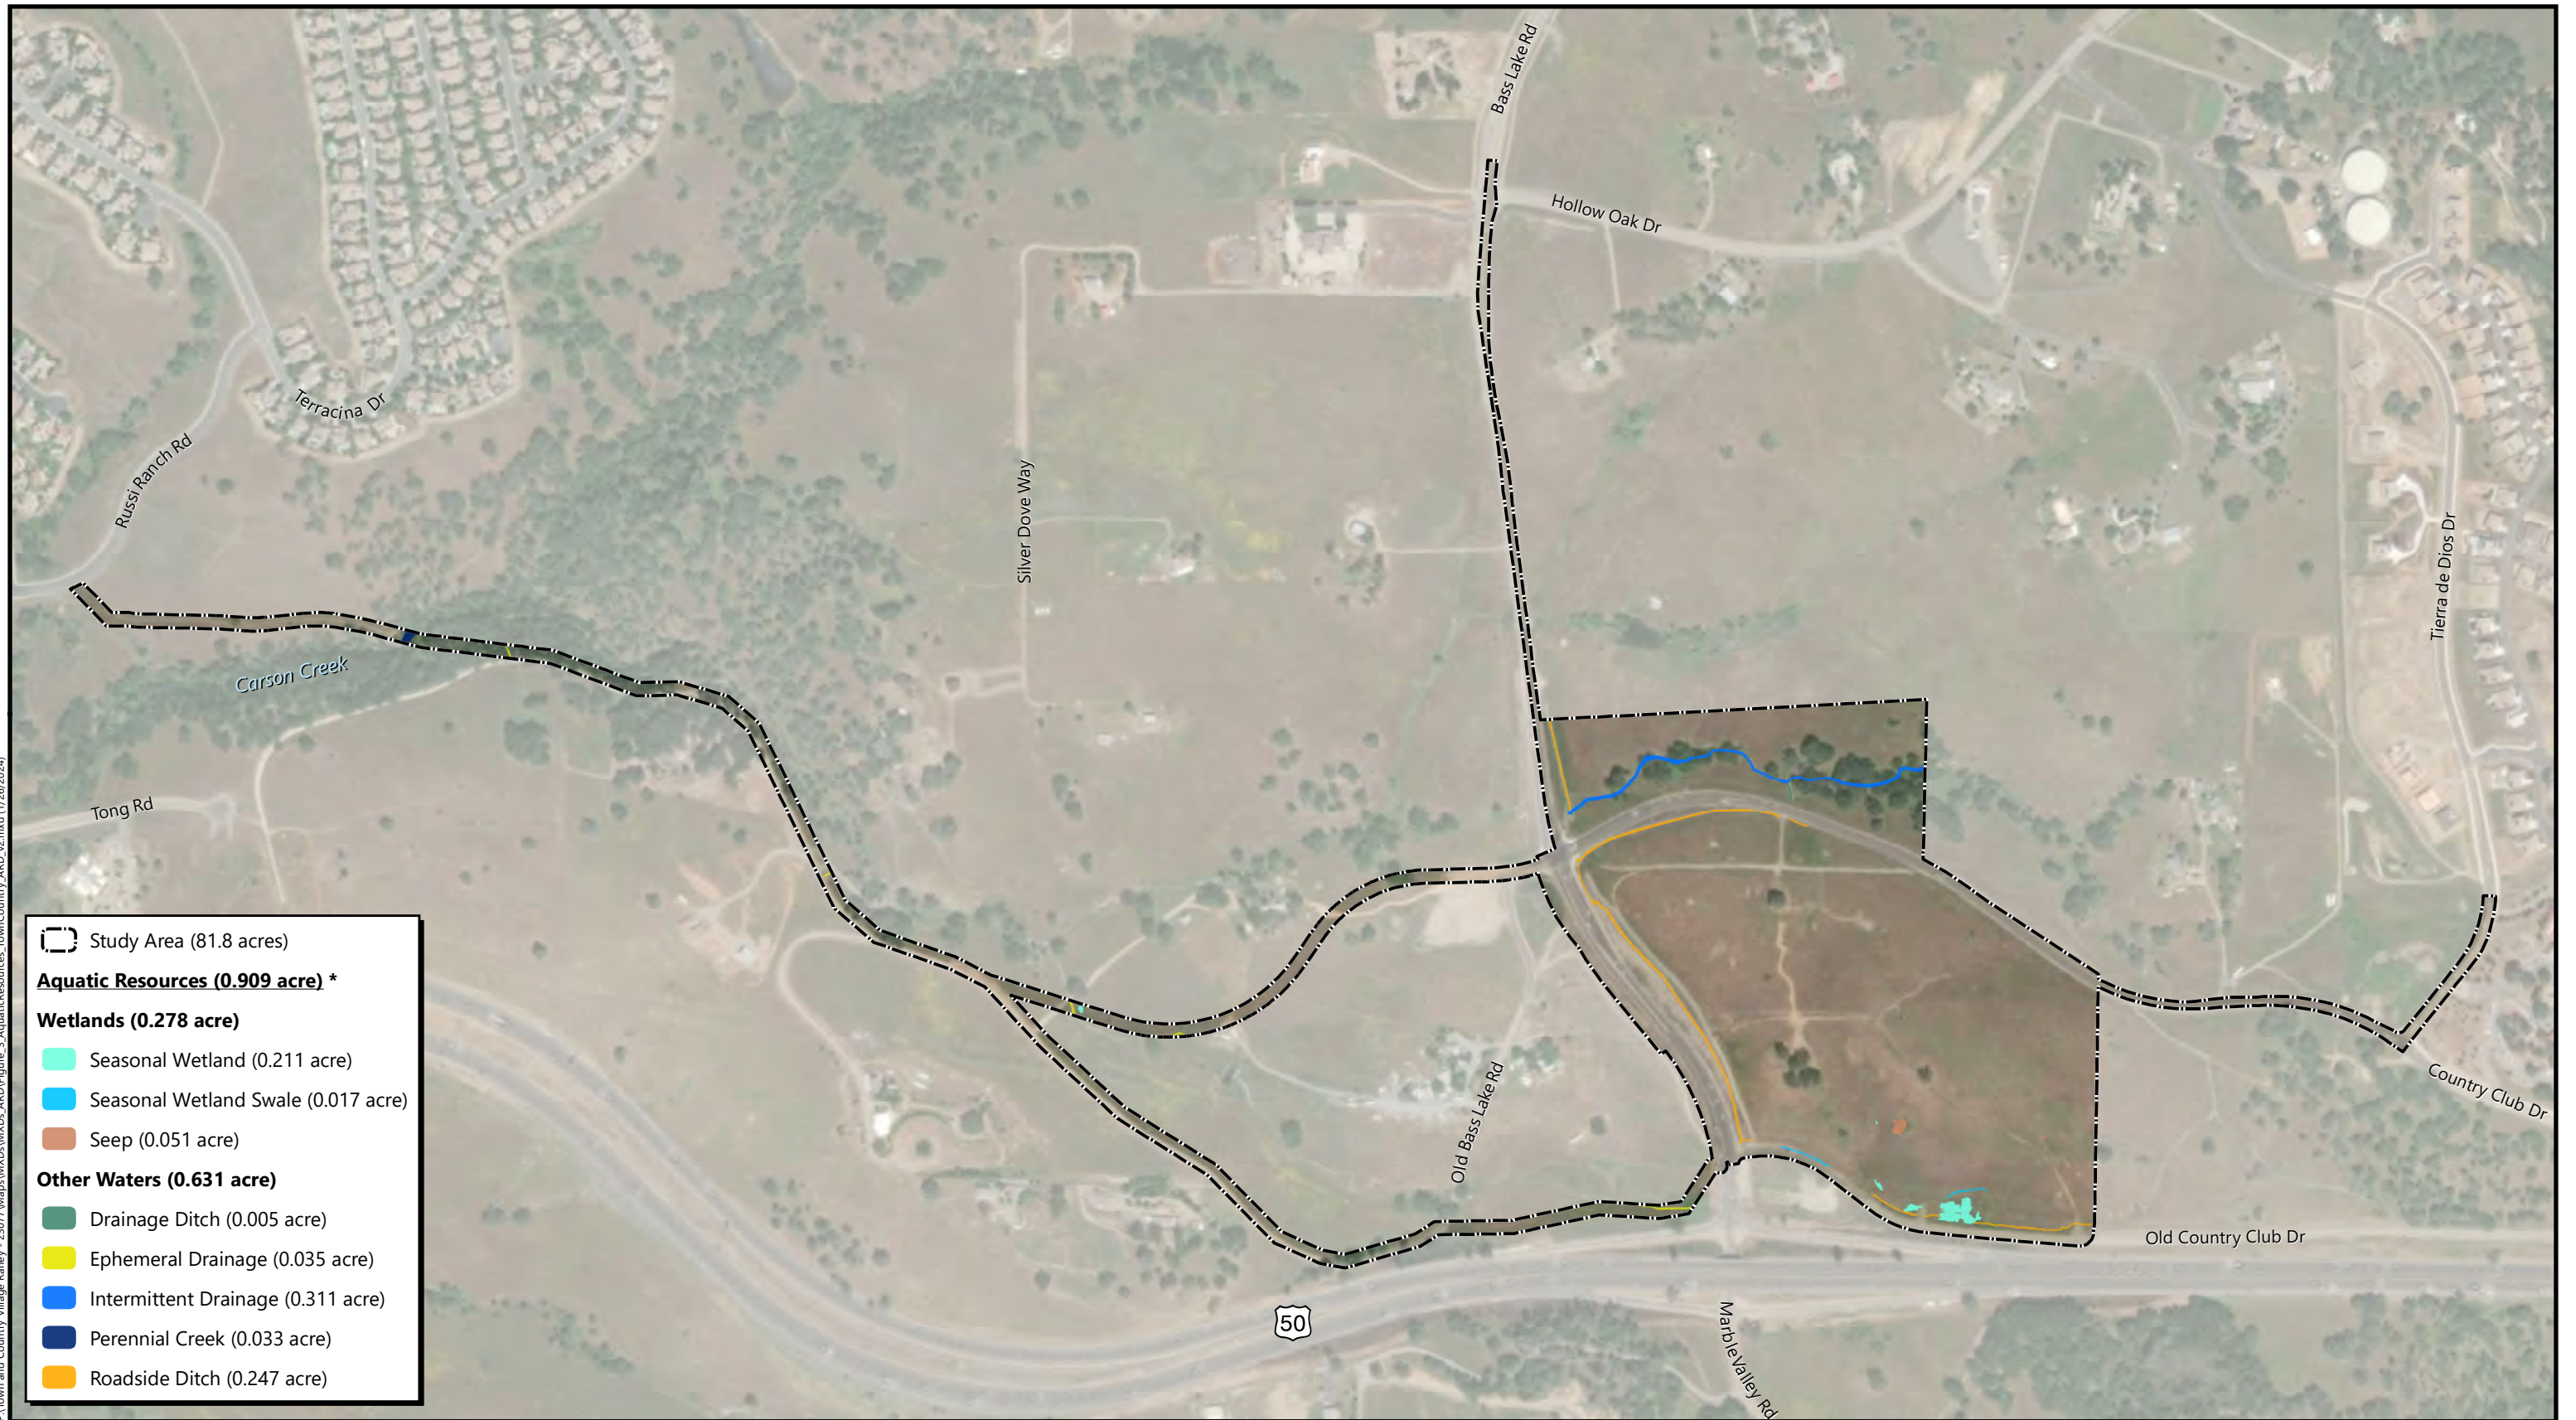
Study Area (81.8 acres)

**Aquatic Resources (0.909 acre) \***

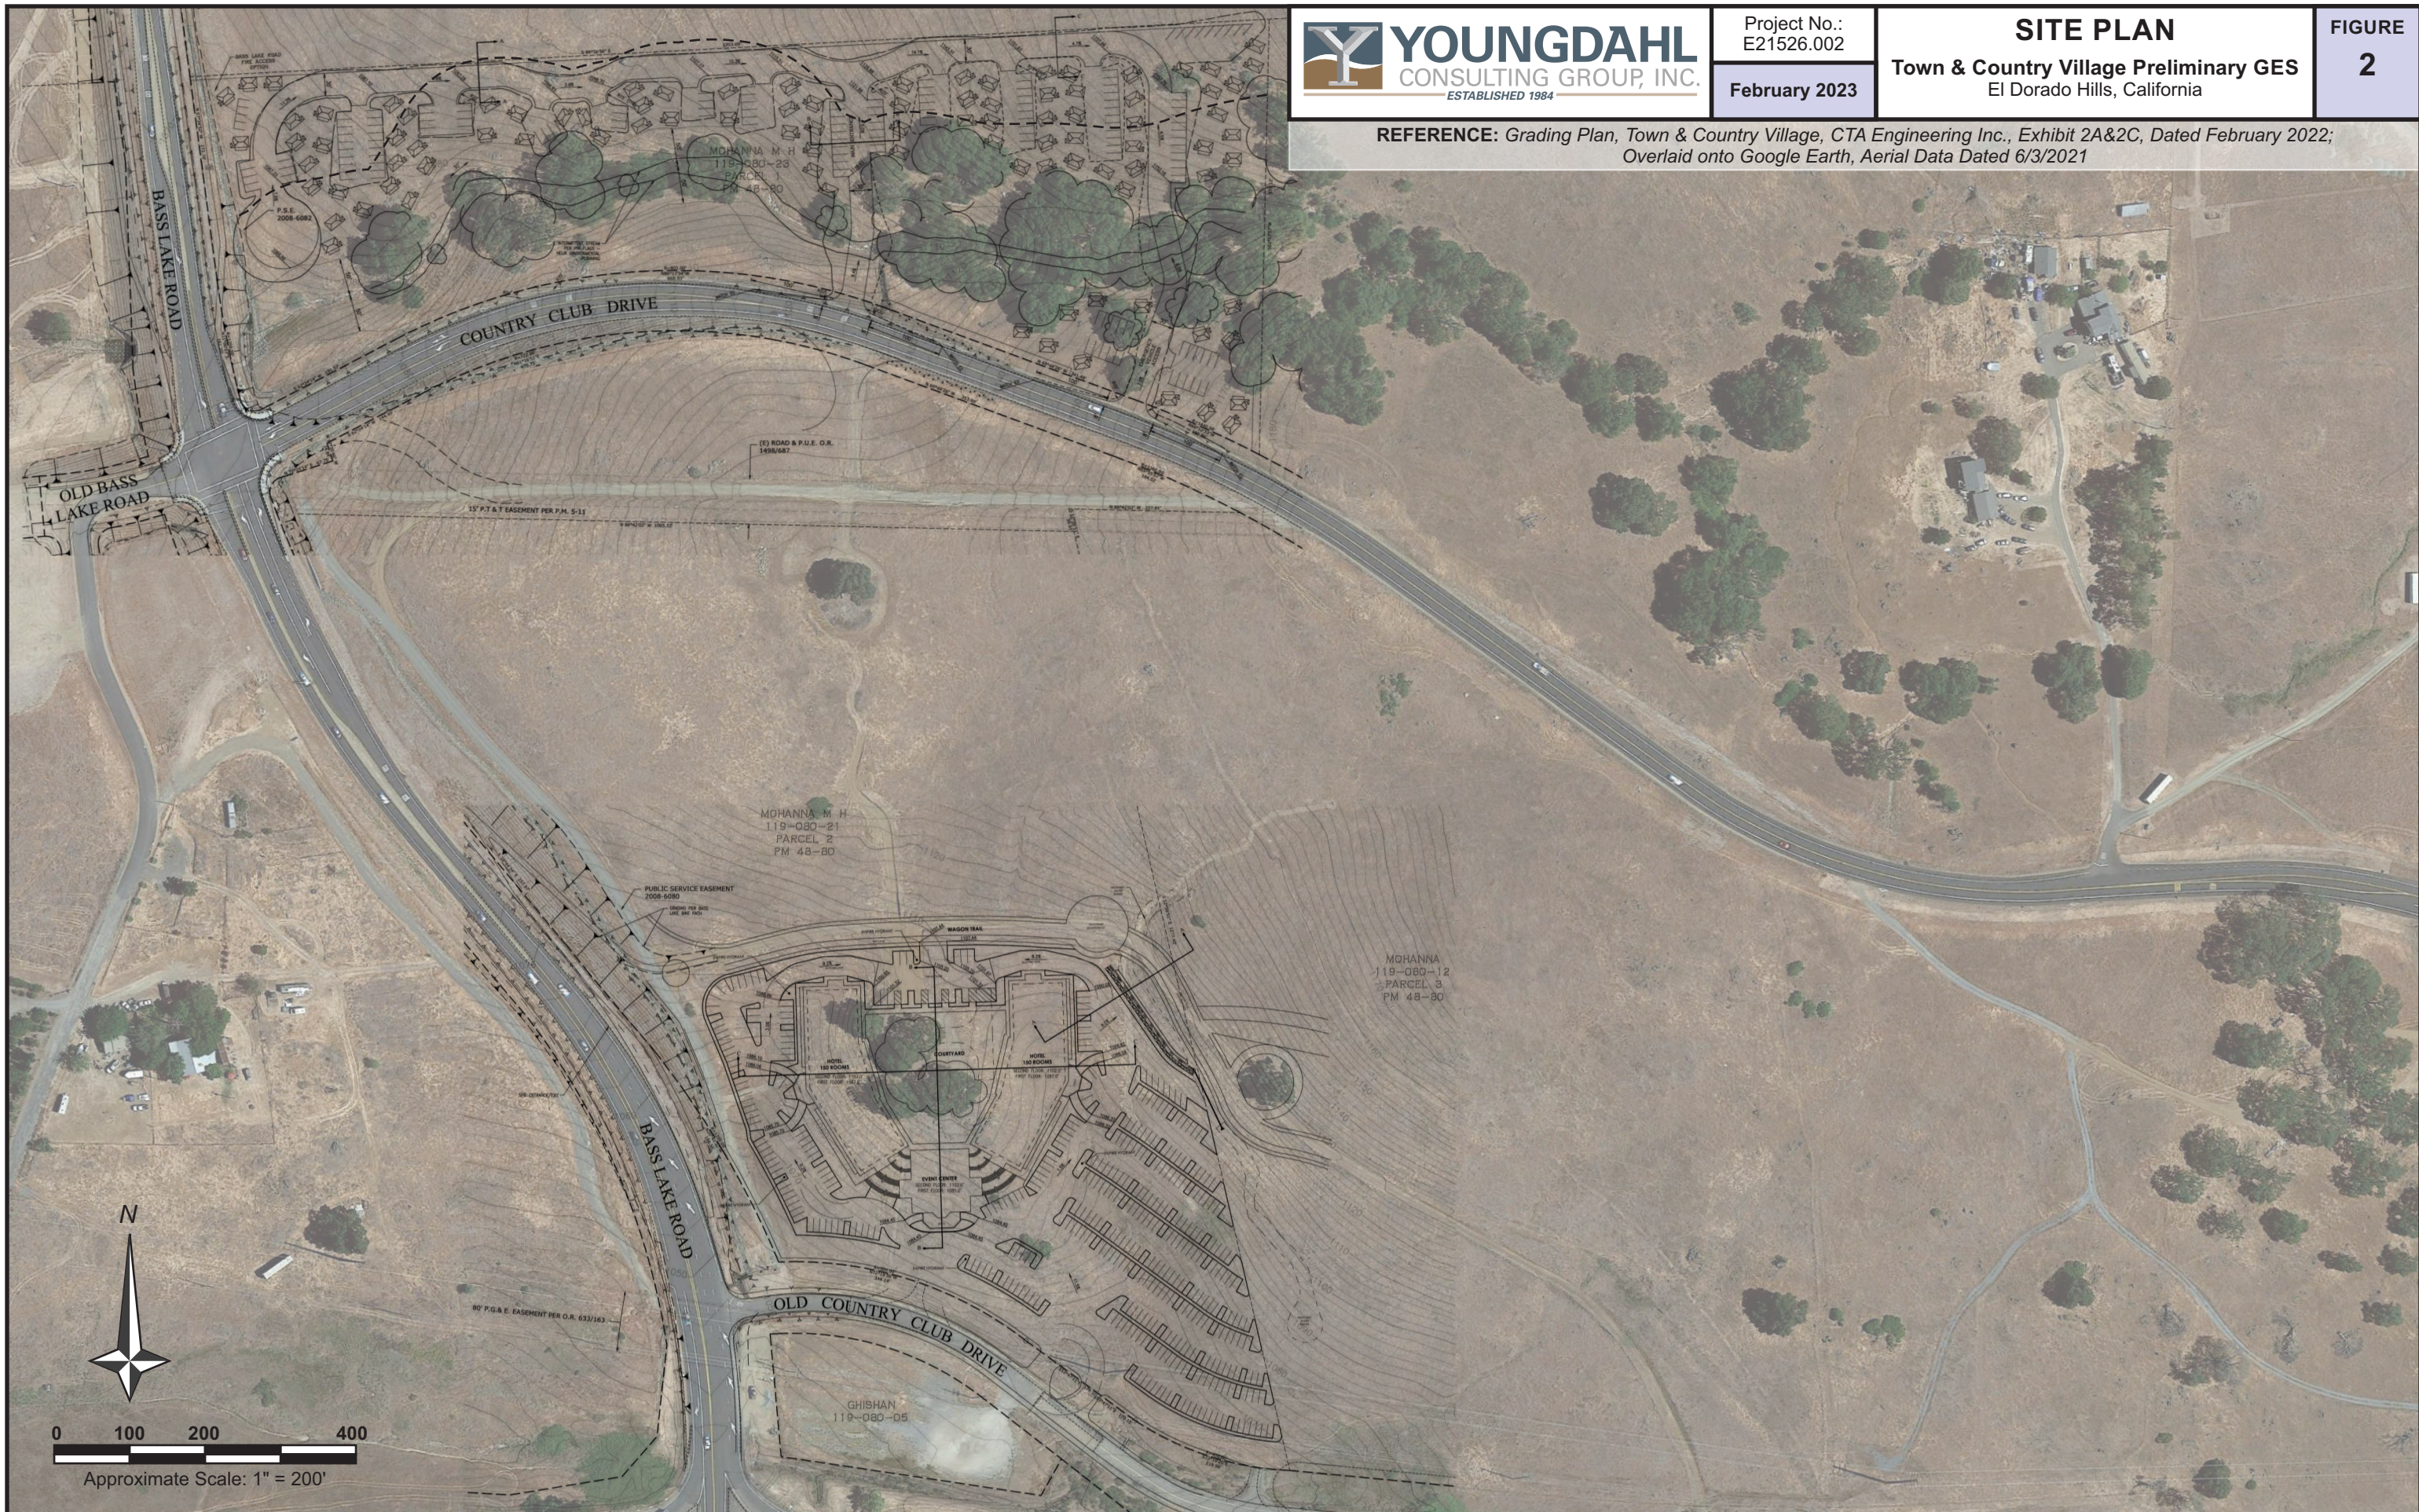
**FIGURE 1**

REFERENCE: Grading Plan, Town & Country Village, CTA Engineering Inc., Exhibit 2A&2C, Dated February 2022;  
Overlaid onto Google Earth, Aerial Data Dated 6/3/2021
